LLL survey

Report Date:
LLL 2019

PURCHASE ORDER NO.:	DOCUMENT NO.:	PROJECT NO.:
	FABYYY	FABYYY
PROJECT TITLE:	Ô•q { ^!Áæ^æCIIIYY EYYEYY	
DOCUMENT TITLE:	F ãÁ•c{ Evaluation & Advisory Service - UNIT L

EXECUTIVE SUMMARY

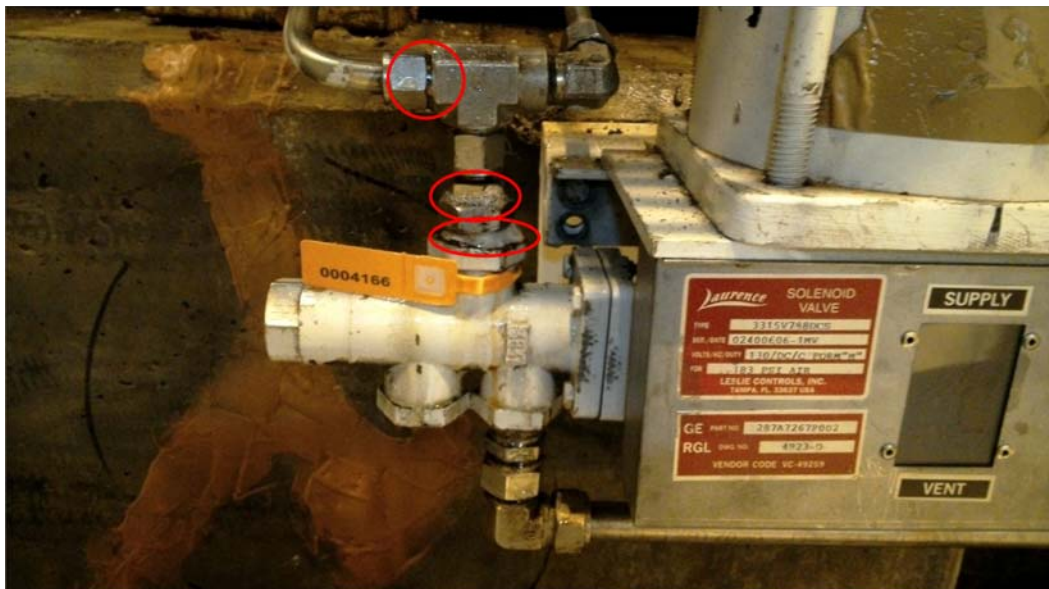
Issue Tag ID : 0004166 **Category : 2**

Plant Area:	YYYY	Part Material:	316 Stainless Steel
Customer Tag ID:		Connection Type:	Tapered Threads
Location:	Air to solenoid valves	Connection Size:	1/2in
GPS Location:			
Part Description:	Stainless Steel Pipe Fitting, Reducing Bushing, 1/2 in. Male NPT x 1/4 in. Female NPT		
Process Fluid:	Compressed air	Type of Part:	Fittings
Pressure:	14 bar	Manufacturer:	Swagelok
Temperature:	20 C	Part Number:	SS-8-RB-4
Issue:	Medium Leak	Equiv Swagelok Part:	
Description:	1/2" MNPT, 1/4" FNPT Reducing bush. Leakage at the top and the bottom of the bush. 1/2" overtightened fitting to the left run of the tee.		
Other Findings:	Overtightened		
Possible Solution:	Investigate source and root cause of the leak and repair or replace as necessary according to manufacturer's instructions		
Ultrasound dB:		n/a	
Ultrasound ID:		n/a
