Intermixing Twin Ferrule Tube Fittings—Is it Safe?

MUSA MIHSEIN & MIKE D. SEYMOUR

Journal of Engineering Design, Vol. 10, No. 4, 1999

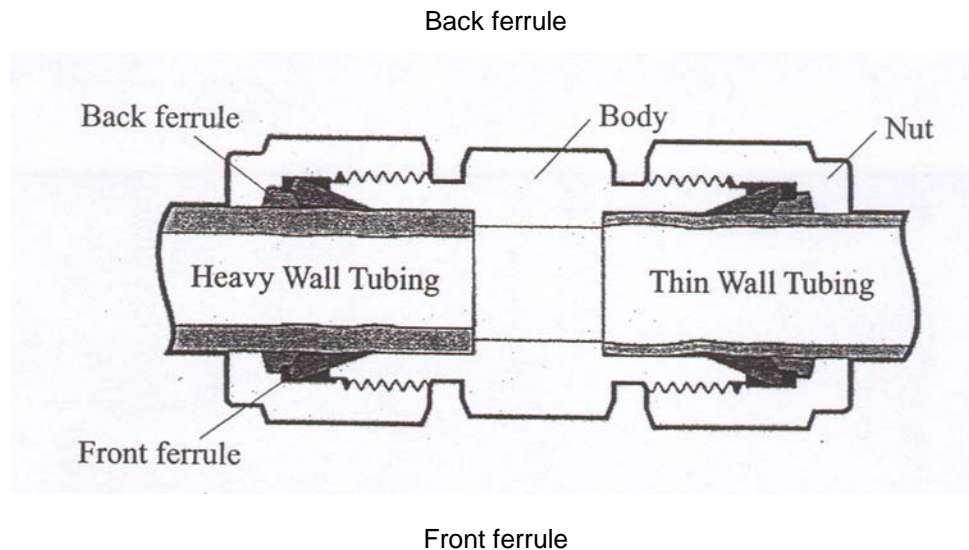
FIG. 1. Union—twin ferrule compression fitting.

Twin ferrule tube fittings comprise a body, front ferrule, back ferrule and a nut. They are delivered from the suppliers already assembled and ready to accept the appropriate size tube. The assembler simply inserts the tube end into the fitting until the end of the tube bottoms up against a shoulder inside the body. Once the tube is located, the nut is turned until it is 'finger-tight' and then using a spanner; it is tightened 1.25 turns. During this tightening process the nut forces the back ferrule forward onto the front ferrule, which then sits on the tapered seat, formed inside the body. During the tightening process the torque increases forcing the noses of both ferrules to just penetrate the outer diameter of the tube creating a swaged metal to metal seal.

Twin ferrule tube compression fittings shown in Fig. 1, were first designed and developed in the USA shortly after the Second World War [1] to meet the ever increasing demands of high-pressure fluid containment. The design has been an unqualified success and as such is used throughout the world, where safety and long-term reliability are of paramount importance. These fittings have many advantages, some of which include:

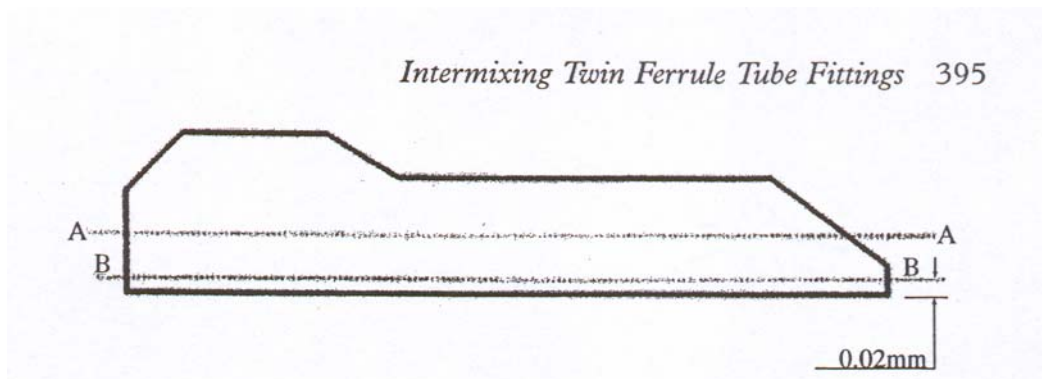
FIG 2. Hardness tests indentation lines.

2.3.4. *Method used to measure hardness profiles of back ferrules.* Hardness test indentations using a 200p load were made along two lines parallel to the bore of the ferrule in steps which varied between 0.20 and 0.10 mm as shown in Fig. 2. Line A—A was along the centreline of the section

and line B—B was approximately 0.02—0.05 mm from the edge of the bore.

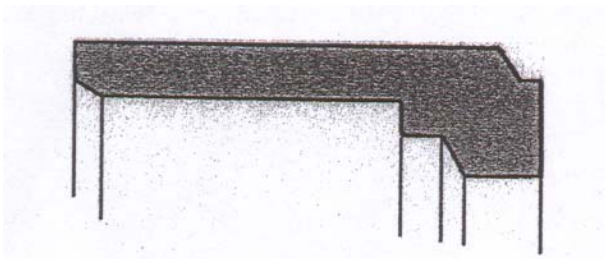
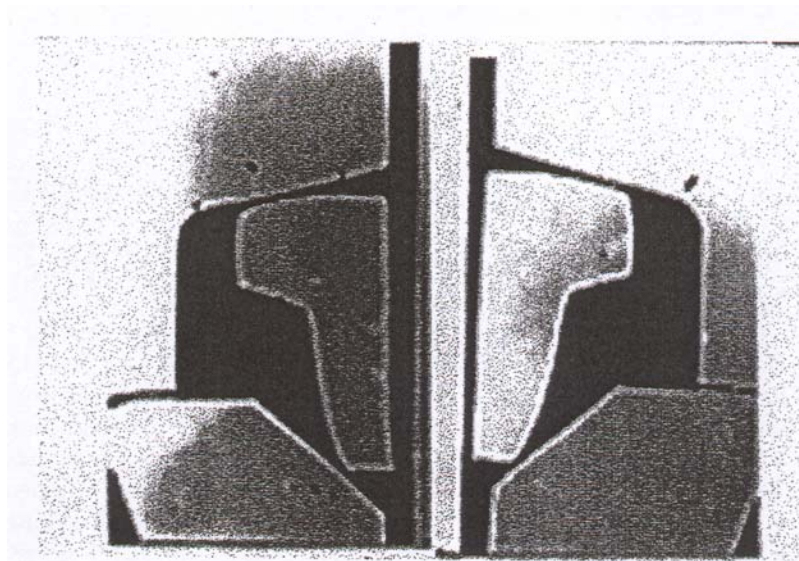
FIG. 6. Company 'B' nut design. FIG. 7. Sectioned intermixed assembly.

The front ferrule was found to include what can be best described as a stepped collar running parallel to the axis, as shown in Fig. 6. The outer surfaces of the other companies' front ferrules were conical throughout. A further significant difference was found in the bore of the front ferrule where a double curved profile exists. to accommodate the curved nose of the back ferrule. All other company designs show a chamfered entry angle of approximately 90° inclusive, to receive the coned nose of their own back ferrules. As the section geometry of company 'B' back ferrules is mainly made up of curves and blending radii, it is difficult to see them being used successfully with other front ferrules as the geometry is incompatible. Intermixing company 'B' ferrules with other designs produced wrongly deformed shapes and no evidence of swaging. This is clearly demonstrated when a 'B' back ferrule is mixed with a 'C' assembly, as shown in a photograph of the sectioned intermixed assembly (Fig. 7)

Further evidence of differences in company 'B's design was seen in the sealing mechanism. As the nut compressed the back ferrule, the nose entered the curved entry recess and followed a route which deflected the nose, causing it to rotate inwardly to penetrate the tube, while the top surface rotated in a congruent arc away from the tube. The other three designs of back ferrule have more of an axial wedging action than a rotary action.

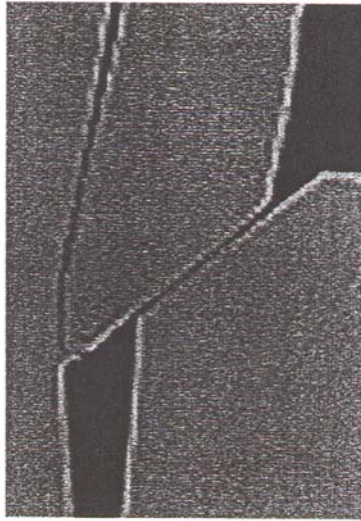
FIG. 8. Cross-sectioned back ferrule.

A photograph of the cross-sectioned back ferrule, shown in Fig. 8, shows ripples along the surface of the ferrules caused by the high compressive load applied by the nut during the swaging process. One possible reason for the difference in pull-up torque between companies 'A' and 'C' is that company 'A' uses a hardening process for the back ferrule which, although harder, is thinner than the surface produced by company 'C' to harden their back ferrule. Evidence to support this view was provided by the torque tests where company 'A' fittings needed an average pull-up torque of 76 N m. Company 'D' fittings required an average torque of 44 N m, as the 'D' back ferrule is hardened only on the surface of the nose leaving the remaining ferrule body soft.

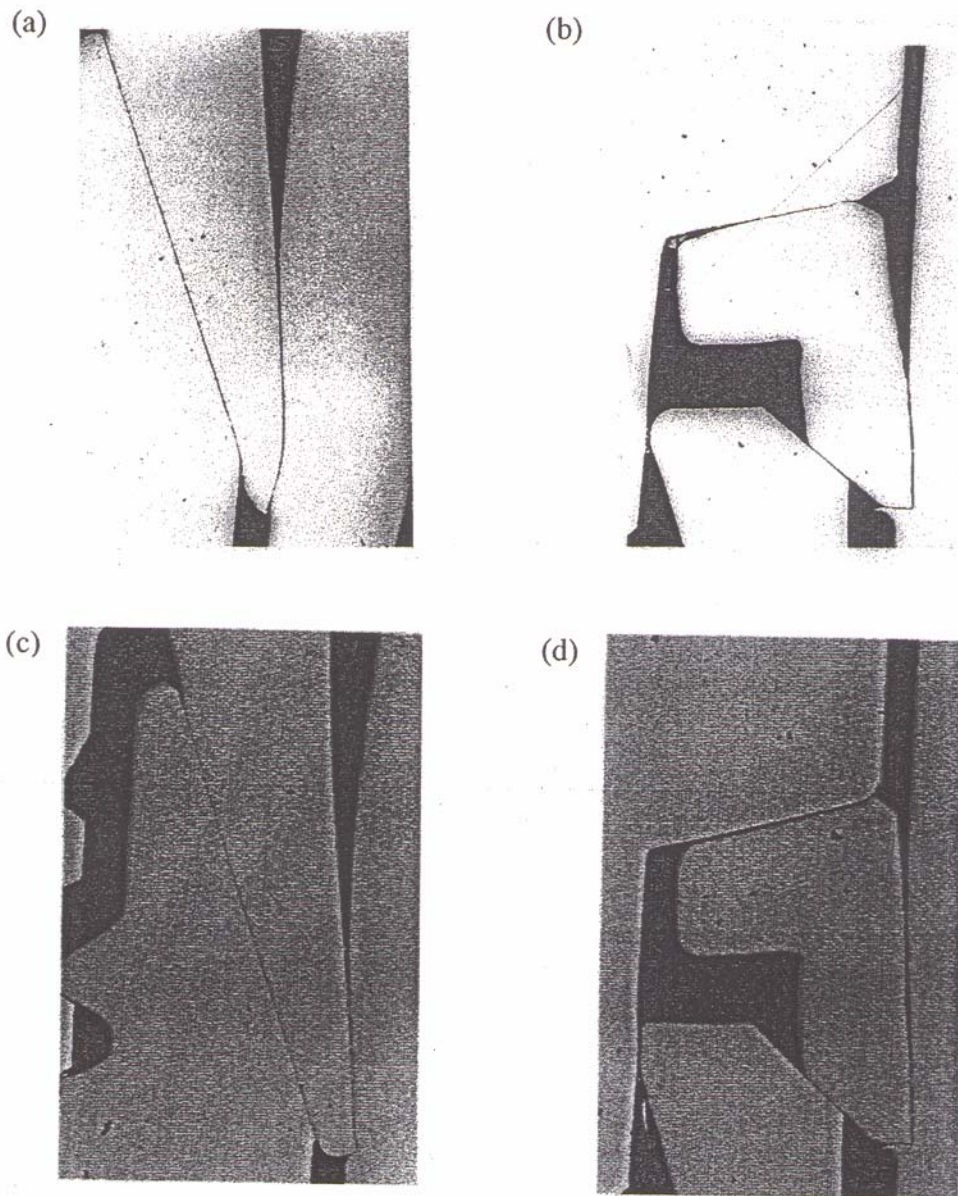
FIG. 9. (a) 'D' body, 'A' back ferrule, 'A' front ferrule and 'A' nut; (b) 'D' body, 'A' back ferrule, 'A' front ferrule and 'A' nut; (c) 'D' body, 'A' back ferrule, 'D' front ferrule and 'A' nut; (d) 'D' body, 'A' back ferrule, 'D' front ferrule and 'A' nut.

The back ferrule, shown in the cross-section photograph, Fig. 9(a), has swaged onto the tube as intended but it has moved further down the back face of the front ferrule than it would if it were a pure Company 'A' fitting, i.e. 1/2 way down as opposed to 1/3 way down. The photograph shown in Fig. 9(b), indicates the reason why this has occurred as it shows the nose of the front ferrule being distorted as it squeezes between the body seating face and the outside diameter of the tube. It is possible, due to the geometric tolerances known to exist, that the front ferrule angular tolerances were such that they did not match those of a pure Company 'D' body and front ferrule and hence the resultant diminished swaging by the front ferrule. Such a combination may pass an initial leak and pressure test, however, further FEA analysis of the fitting is required to determine the stress distribution. This will show whether any stress raisers have been introduced which could cause fatigue failure under operational conditions. It is therefore safe to conclude without further studies this combination should not be practiced or recommended.

9(d) with photograph Fig. 9(b). Here it can be seen that the angle between the bore of the back ferrule and the outside diameter of the tube is greater in Fig. 9(b) than that shown in Fig. 9(d). In addition, it can be seen that some extrusion is evident along the top inside edge of the back ferrule again providing evidence of high torque when compared with a pure Company 'D' fitting. As this intermixed test was assembled with a mixture of new components it may have initially held pressure but for how long and under what conditions is not known. Only extensive FEA simulating predicted conditions and practical evaluation would provide a user with sufficient data to establish long-term reliability of this combination.

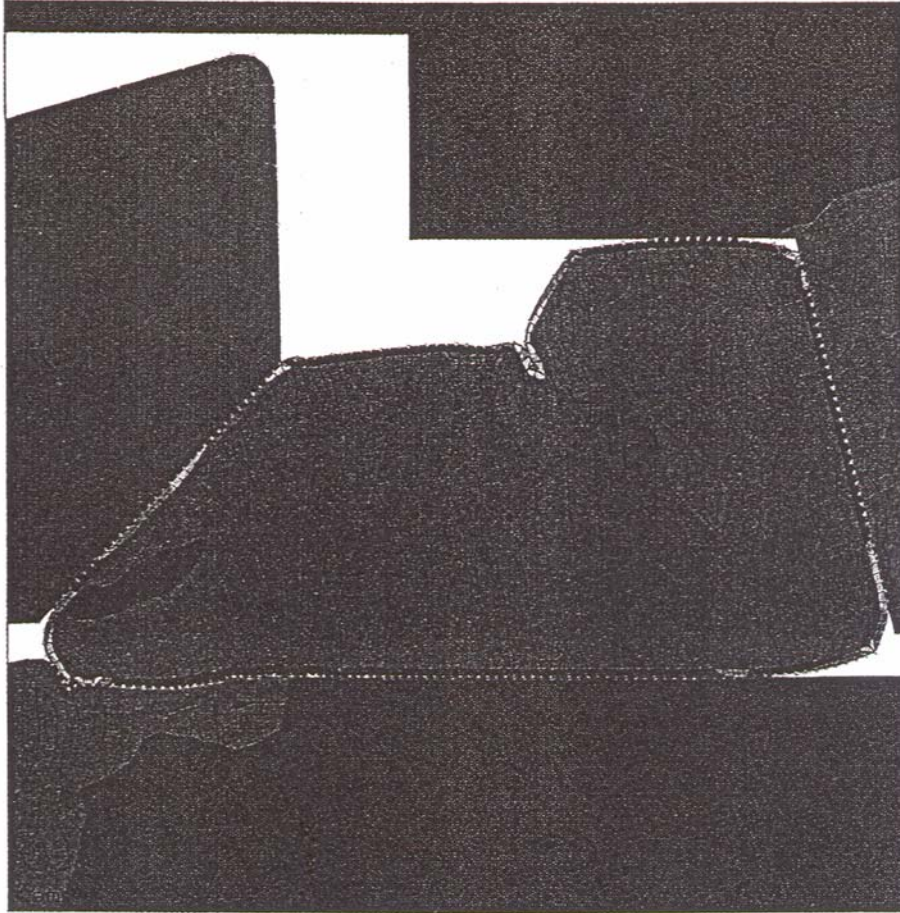
FIG. 5. FEA plot for Company 'A' back ferrule.

This influences the sealing process to the extent that much of the axial force required to pull up the fitting is expended in compressing the back ferrule, which is confirmed by the relatively high pull-up torque (average 76 N in). Meanwhile, as the nose of the back ferrule penetrates the wall of the tube, the axial load causes about a third of the inner surface of the ferrule, from the nose, to tipple demonstrating a classic buckling effect. This can be seen on the baseline FEA plots for company 'A' shown in Fig. 5.

The second difference observed was that after 1.25 turns, the outer diameter of the back ferrule (see Fig. 5) did not bow outwardly under the compressive load to the same extent as the ferrules designed by companies 'C' and 'D'. This again is probably due to the strength imparted to the ferrule by the high level of surface hardening.

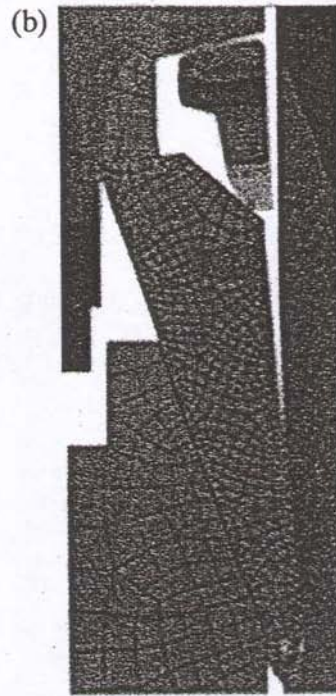
FIG. 14. (a), (b). Intermixed Test 2 – Cross-section photograph and FEA plot of Von Mises stress profile.

The pull-up torque's were high at 69 and 77 N m, respectively, compared with an average torque of 44 N m for pure company 'D' fittings. Photographs of the cross-sectioned fittings (see Fig. 1 4a) show that the back ferrule does not even touch the wall of the tube and in fact plays no part whatsoever in the sealing mechanism. Further study of the shape of the front ferrule shows good agreement with the photographs and plots (see Fig. 14b).

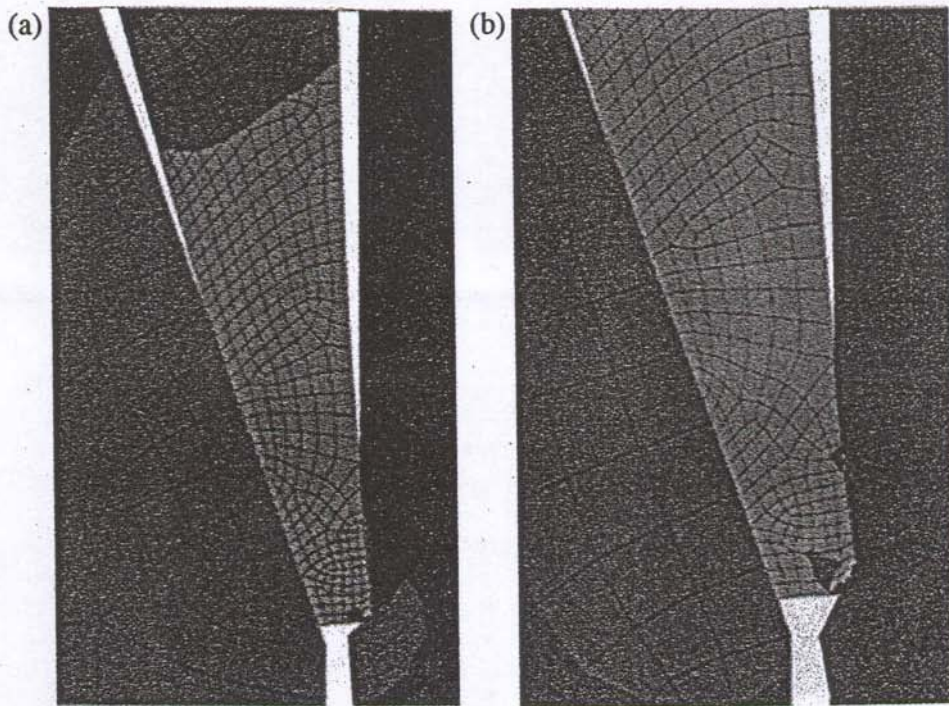
FIG. 15. (a), (b). Intermixed Test 4 – FEA plots of front ferrule differences.

This test combined a 'D' body and 'C' ferrules and nut. Again, this test was aimed at OEMs that could be using company 'D' and 'C' fittings. It must be stressed also that components used in this combination were unused. Pull-up torque's for right- and left-hand sides were 100 and 122 N m, respectively, and no leaks were observed during the 690 kPa leak test and the subsequent high-pressure test. Careful study of the two FEA models of Von Mises stress profiles show good agreement apart from a different stress distribution pattern and geometry at the tip of the front ferrule (see Fig. 15). In this case, as the body is the only component to be intermixed from new, then such a combination may work under operational conditions. However, if these two companies' products are being used simultaneously, then other component parts could be intermixed inadvertently with unknown consequences.

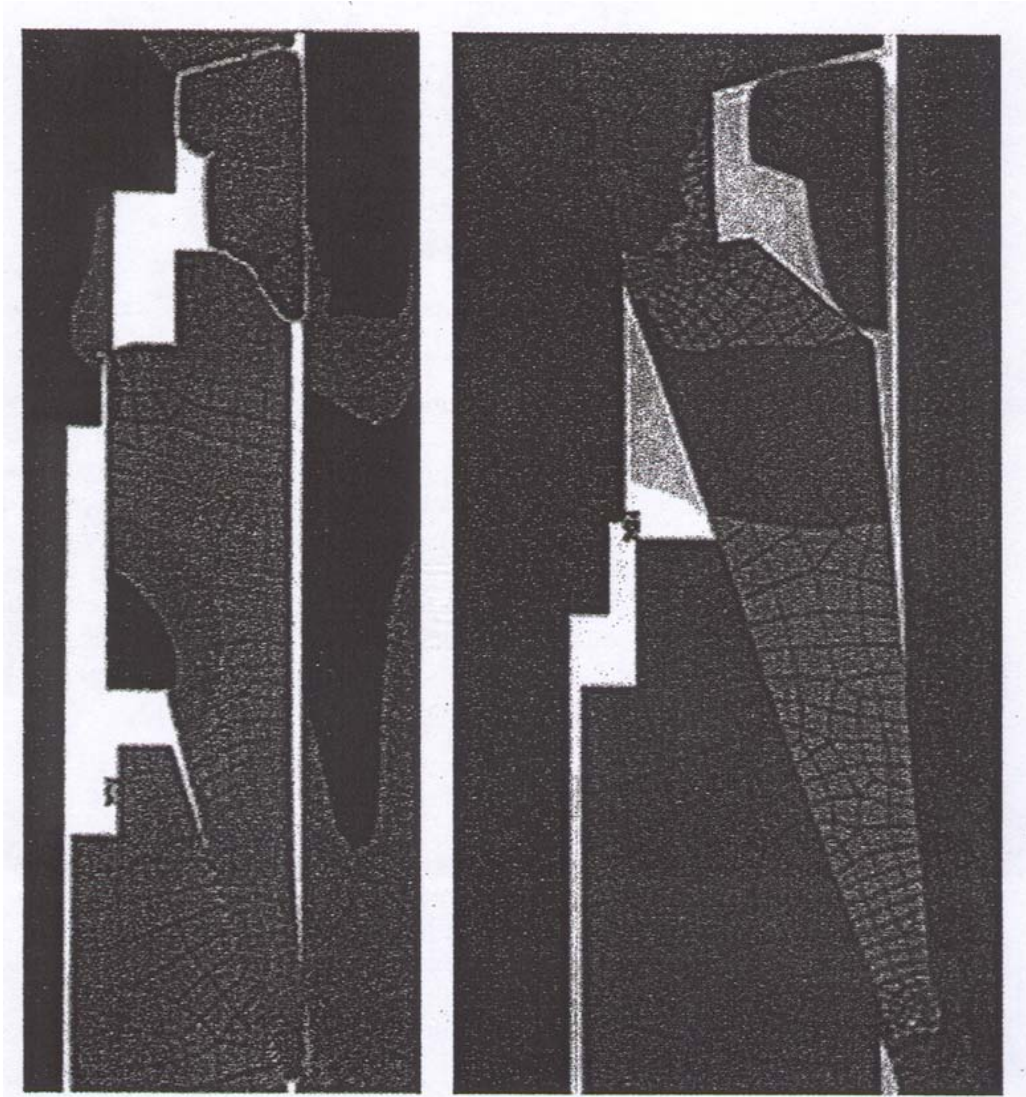
The pull-up torque's were quite low at 38 and 39 N m left- and right-hand sides, respectively. Figure 16 clearly shows that the back ferrule has wedged itself between the top end of the front ferrule and the tube, with little evidence of any swaging of the back ferrule hence the reason for the low torque encountered. However, the FEA model (Fig. 17) shows some indentation of the tube by the back ferrule but the depth is smaller than that produced by a pure company 'C' assembly. In addition, the FEA model shows that the front ferrule is making contact with the nut, causing the outer edge of the front ferrule to deform in a manner not intended. This combination proved leak-tight at both low and high pressures.

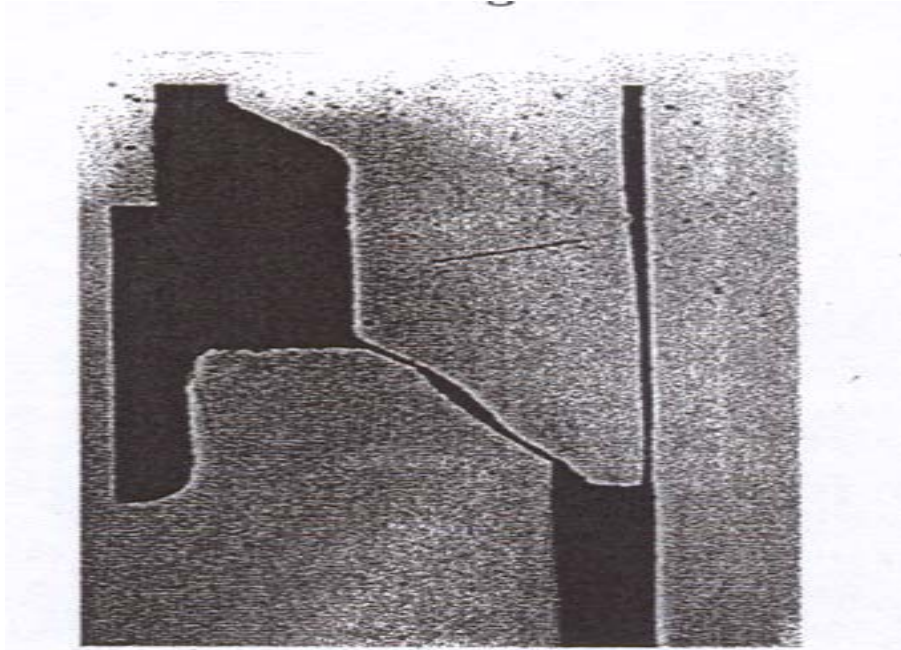
Test 6 was an intermix of a company 'C' assembly and a company 'B' assembly back ferrule. The FEA model of Von Mises stress profiles are showing in Fig. 18, where it is seen that the back ferrule plays no part in the intended sealing mechanism.

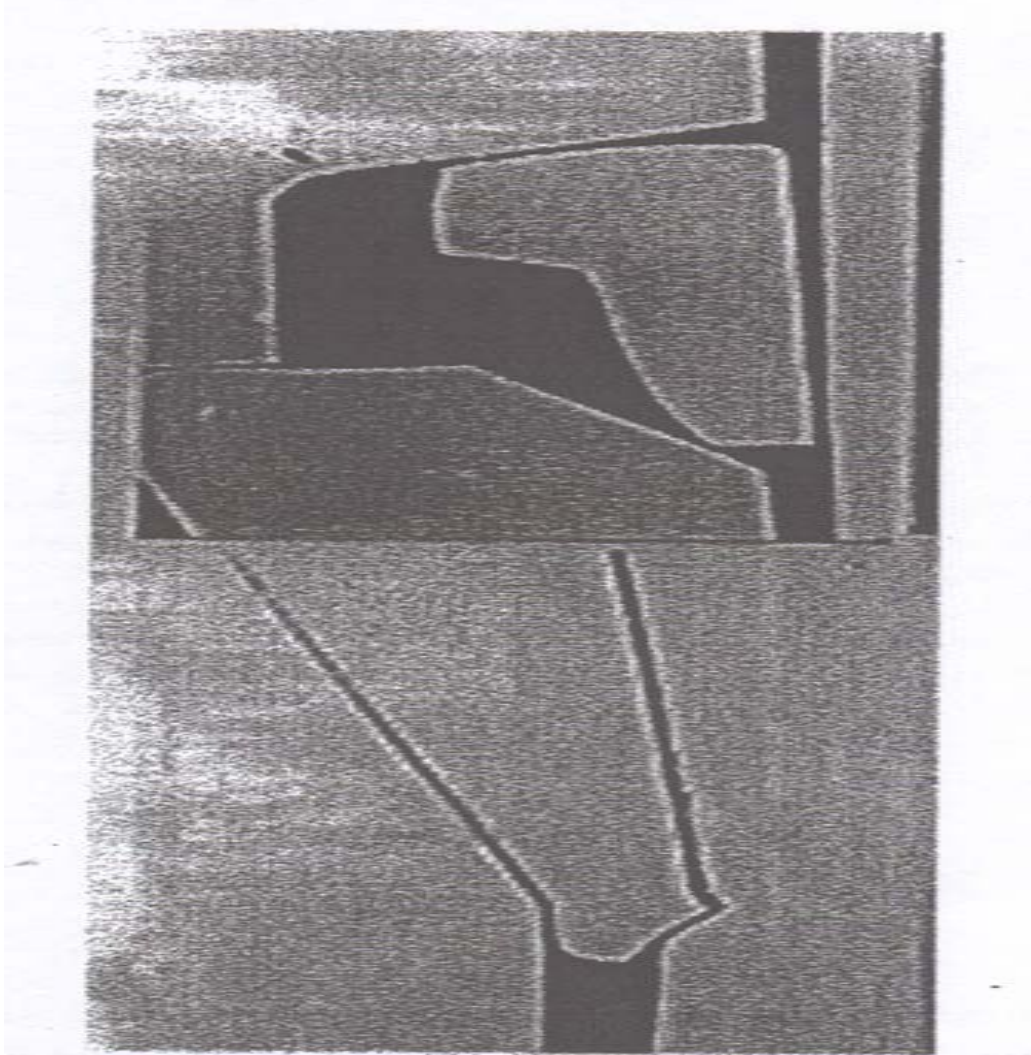
A photograph of the assembled cross-section (Fig. 19) confirms the FEA result. This intermix combination demonstrates the deviation from the intended parent assemblies and showed that it relied entirely upon material being forced into the wrong places, and imposed stresses on the nut in places where it is not designed to take stresses.
