PTR-5008 Ver 01 June 2022 Page 1 of 5

TITLE

Chloride Stress Corrosion Cracking (CSCC) Test of 316 Stainless Steel Swagelok[®] FK Medium-Pressure Fittings and Another Brand of 316 Stainless Steel Medium-Pressure Fittings while Pressurized to 15 000 psig (103.4 MPa)

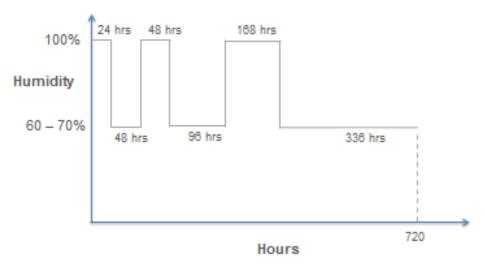
Dual Cycle Humidity Test – at 65°C

Figure 1: Cyclic humidity corrosion salt spray schedule

- 5. Samples were pressurized with water to 15 000 psig (103.4 MPa) and held at that pressure throughout the CSCC test.
- 6. The chamber temperature was elevated to 65°C (149°F) and the following salt spray schedule, derived from SAE J2334 and ASTM B117, was initiated:

- a. continuous salt spray maintained at 65°C for 24 hours
 - b. salt spray turned off, 60% to 70% relative humidity maintained at 65°C for 48 hours
 - c. repeat step a for 48 hours

- d. repeat step b for 96 hours
 - e. repeat step a for 168 hours
 - f. repeat step b for 336 hours, for a schedule total of 720 hours (see **Figure 1**)

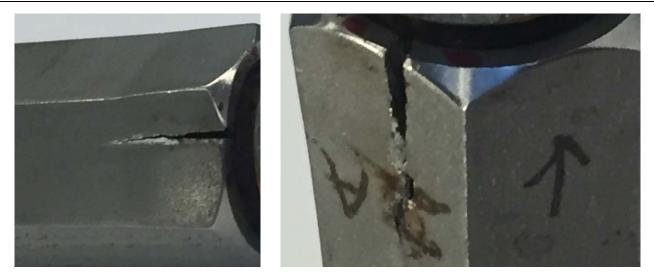
Figure 2: Examples of cracks on Another Brand's 316 SS fitting body

- 9. The samples were then disassembled. The body components were examined by 100× optical microscope for presence of cracks extending from either end along the barstock surface.

Swagelok FK Medium-Pressure Fittings		Another Brand of Medium-Pressure Fittings	
Description	Manufacturer specified assembly	1/8 additional nut turn	Manufacturer specified assembly	1/8 additional nut turn
Number of fittings exhibiting leakage, pre- and post-salt spray nitrogen gas pressure tests	0 of 44	0 of 44	0 of 12	0 of 12
Number of fittings exhibiting leakage during 720 hours CSCC test	0 of 44	0 of 44	0 of 12	0 of 12
Number of fittings showing visible body cracks along the barstock surface (see Figure 2)	0 of 44	0 of 44	4 of 12 (33%)	3 of 12 (25%)

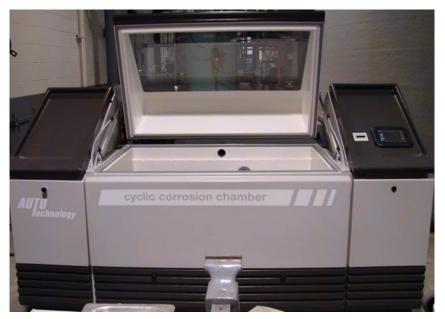
Figure 3: Auto Technology Cyclic Corrosion Chamber

- 3. Each sample was pressurized with nitrogen to 15 000 psig (103.4 MPa) and monitored for leakage for 10 minutes prior to the CSCC test.
- 4. Samples were placed into a salt spray chamber (see **APPENDIX**) that utilized substitute ocean water per ASTM D1141.

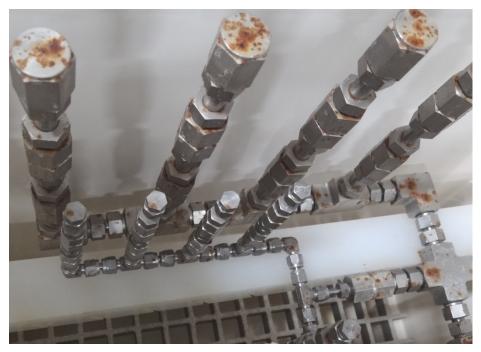
Figure 4: Pressurized FK Medium-Pressure Fittings in Cyclic Salt Spray Chamber
